Final Report

Taylor Lumber and Treating Superfund Site Final Construction Report

Prepared for
U.S. Environmental Protection Agency

March 2009

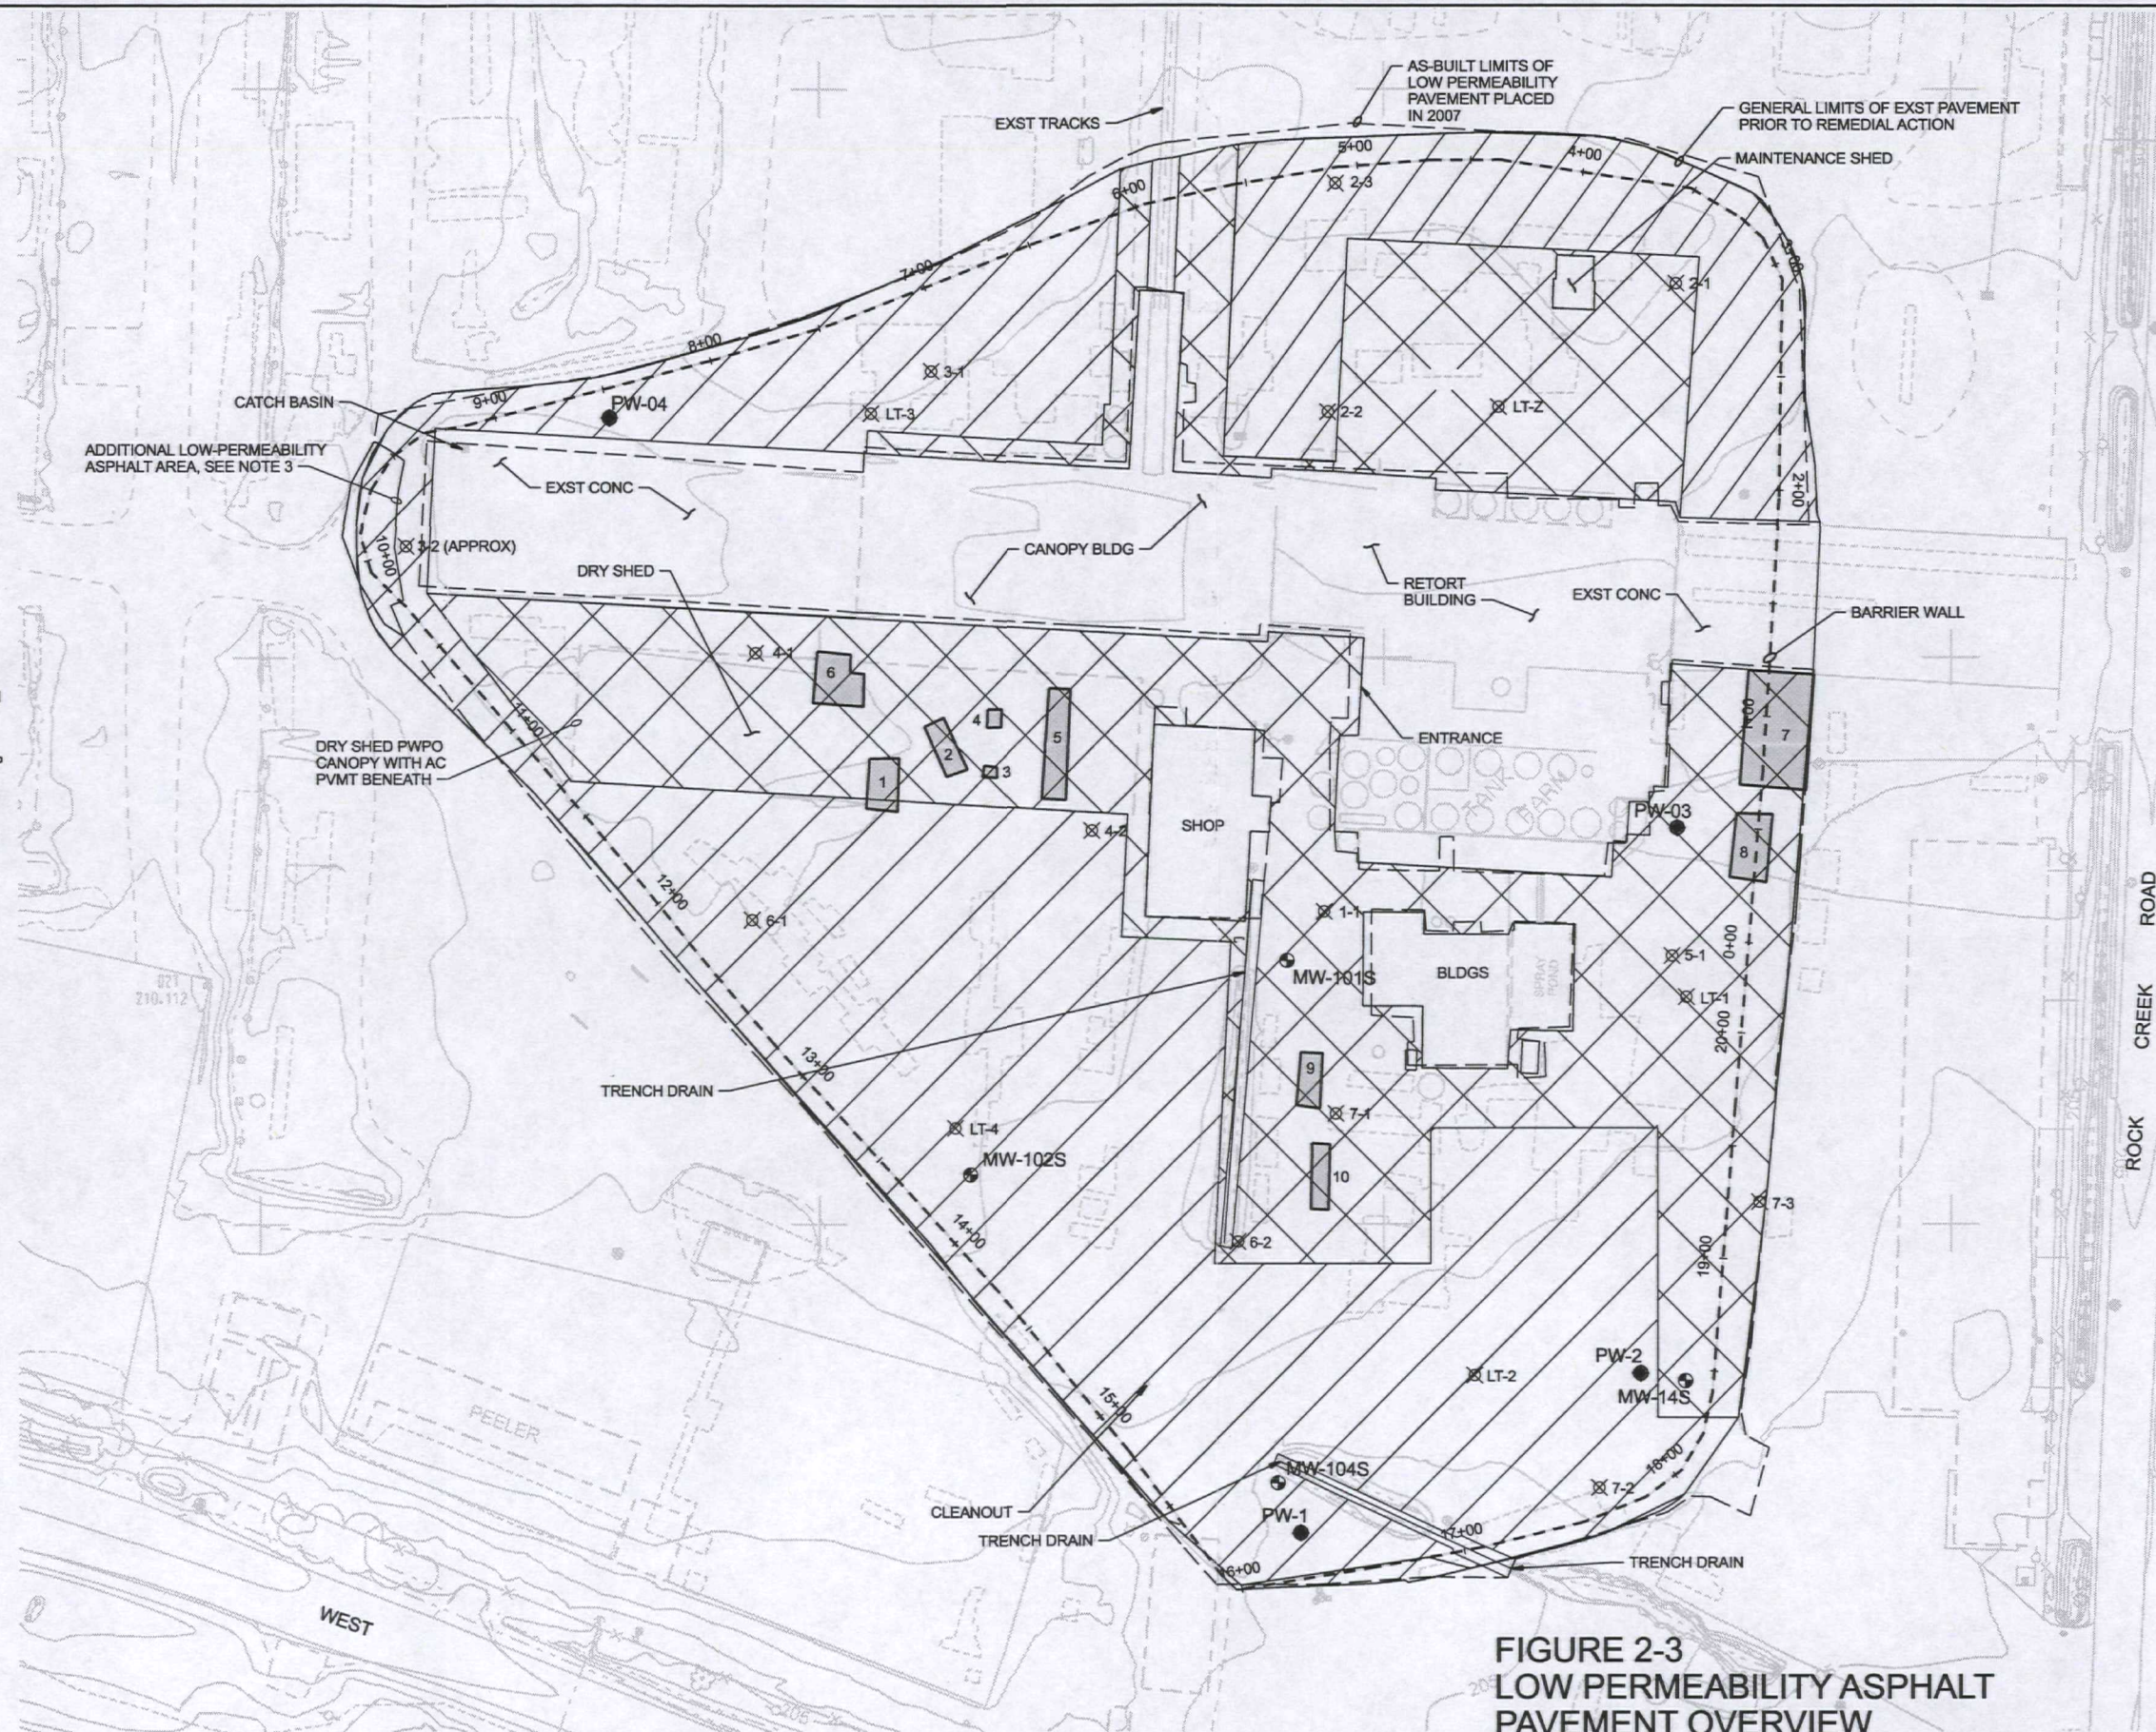
FIGURE 2-3
LOW PERMEABILITY ASPHALT
PAVEMENT OVERVIEW
 TAYLOR LUMBER AND TREATING SUPERFUND SITE

1. ASPHALT PATCHES #1, #2, #3 AND #5 FAILED SUBGRADE COMPACTION REQUIREMENTS AND ARE COVERED BY A 5-YEAR SUPPLEMENTAL WARRANTY (DATED JAN 2, 2008) FROM BAKER ROCK RESOURCES.
2. LOW PERMEABILITY ASPHALT OVERLAY MEASURES APPROXIMATELY 5.37 ACRES. (EXCLUDING EXISTING BUILDINGS). OUTER LIMITS OF LOW PERMEABILITY ASPHALT CAP MEASURES APPROXIMATELY 6.75 ACRES (INCLUDING BUILDING ACRES).
3. A 1,455 SF AREA OF LOW PERMEABILITY ASPHALT WAS ADDED AFTER COMPLETION OF PAVING OPERATIONS. THIS AREA WAS ADDED BECAUSE THE ORIGINAL PAVING LIMITS DID NOT EXTEND OUTSIDE OF THE BARRIER WALL CENTERLINE TO THE LIMITS SHOWN IN THE DESIGN DRAWINGS.
